AFWAL-TR-85-3125

AIRCRAFT TRANSPARENCY TEST METHODOLOGY

Final Technical Report for Period June 1984 - September 1985

FLIGHT DYNAMICS LABORATORY
AIR FORCE WRIGHT AERONAUTICAL LABORATORIES
AIR FORCE SYSTEMS COMMAND
WRIGHT-PATTERSON AIR FORCE BASE, OHIO 45433

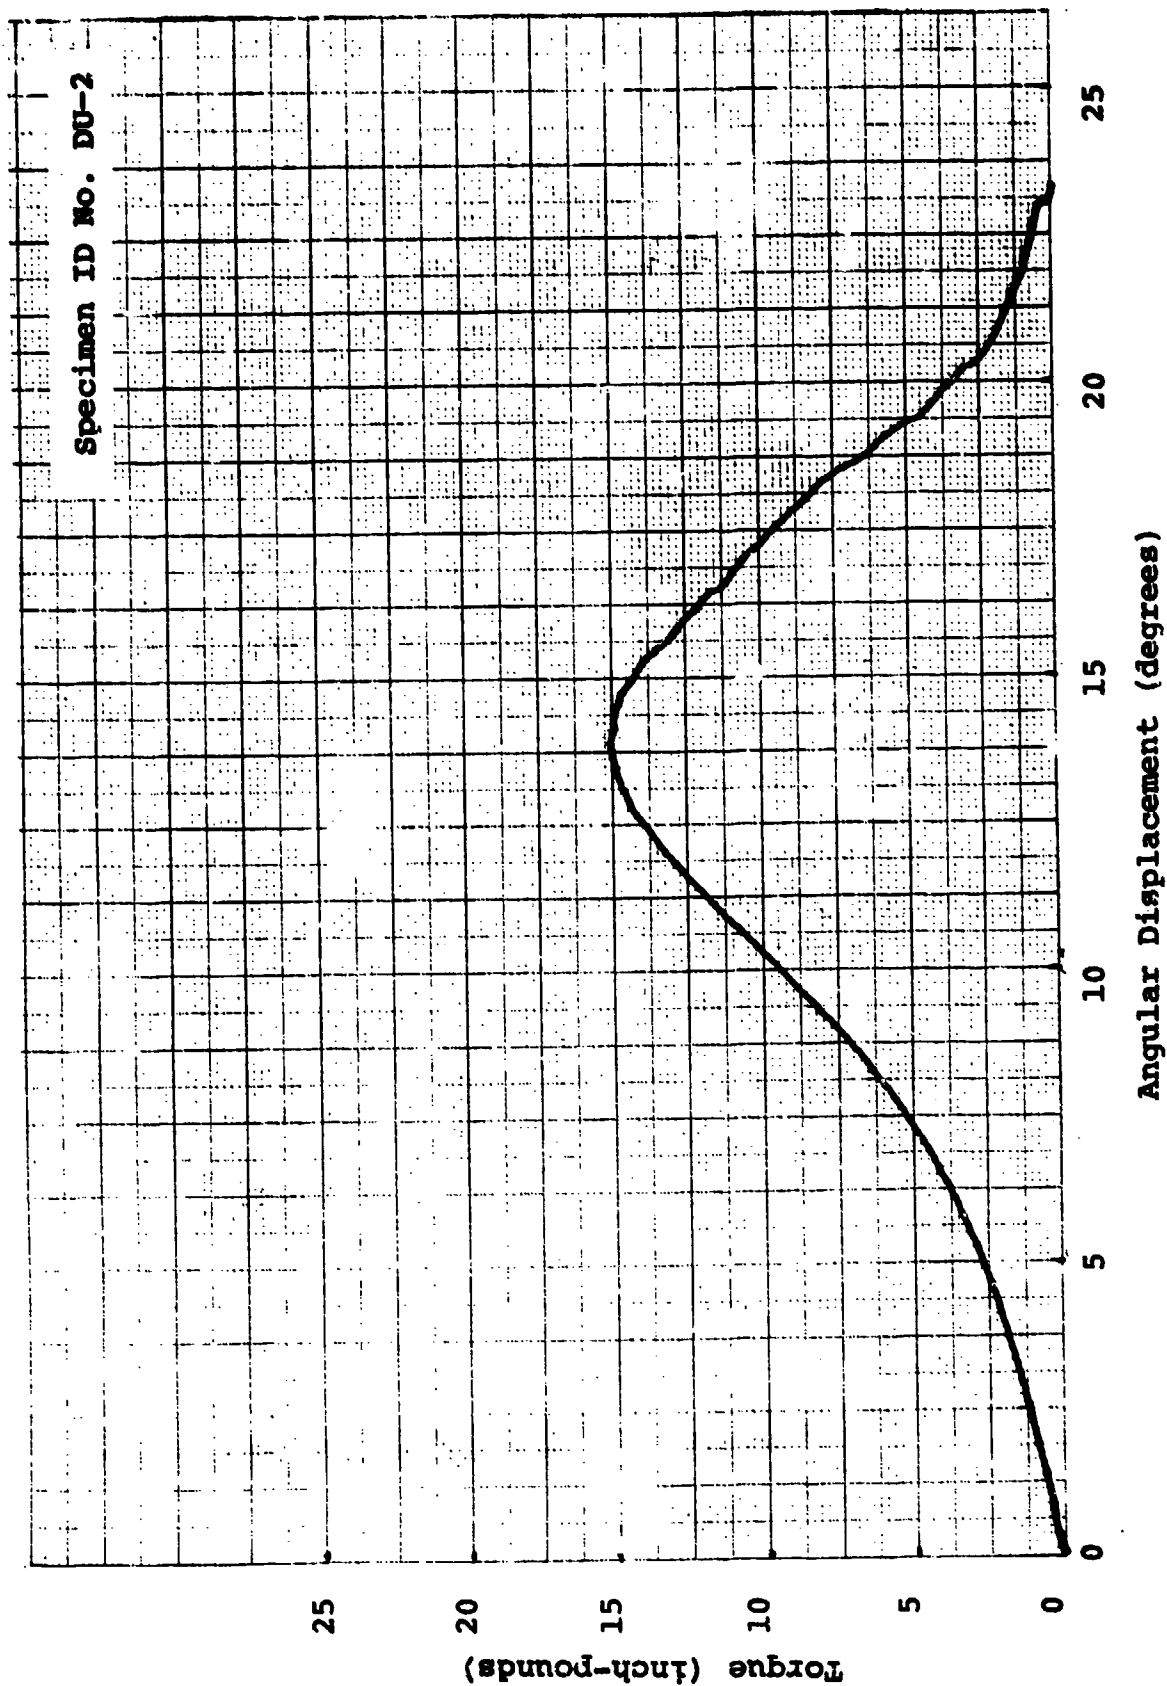
Figure 3.36. Typical Torque vs. Angular Displacement Plot, Torsional Shear, F-16A Laminated Canopy.

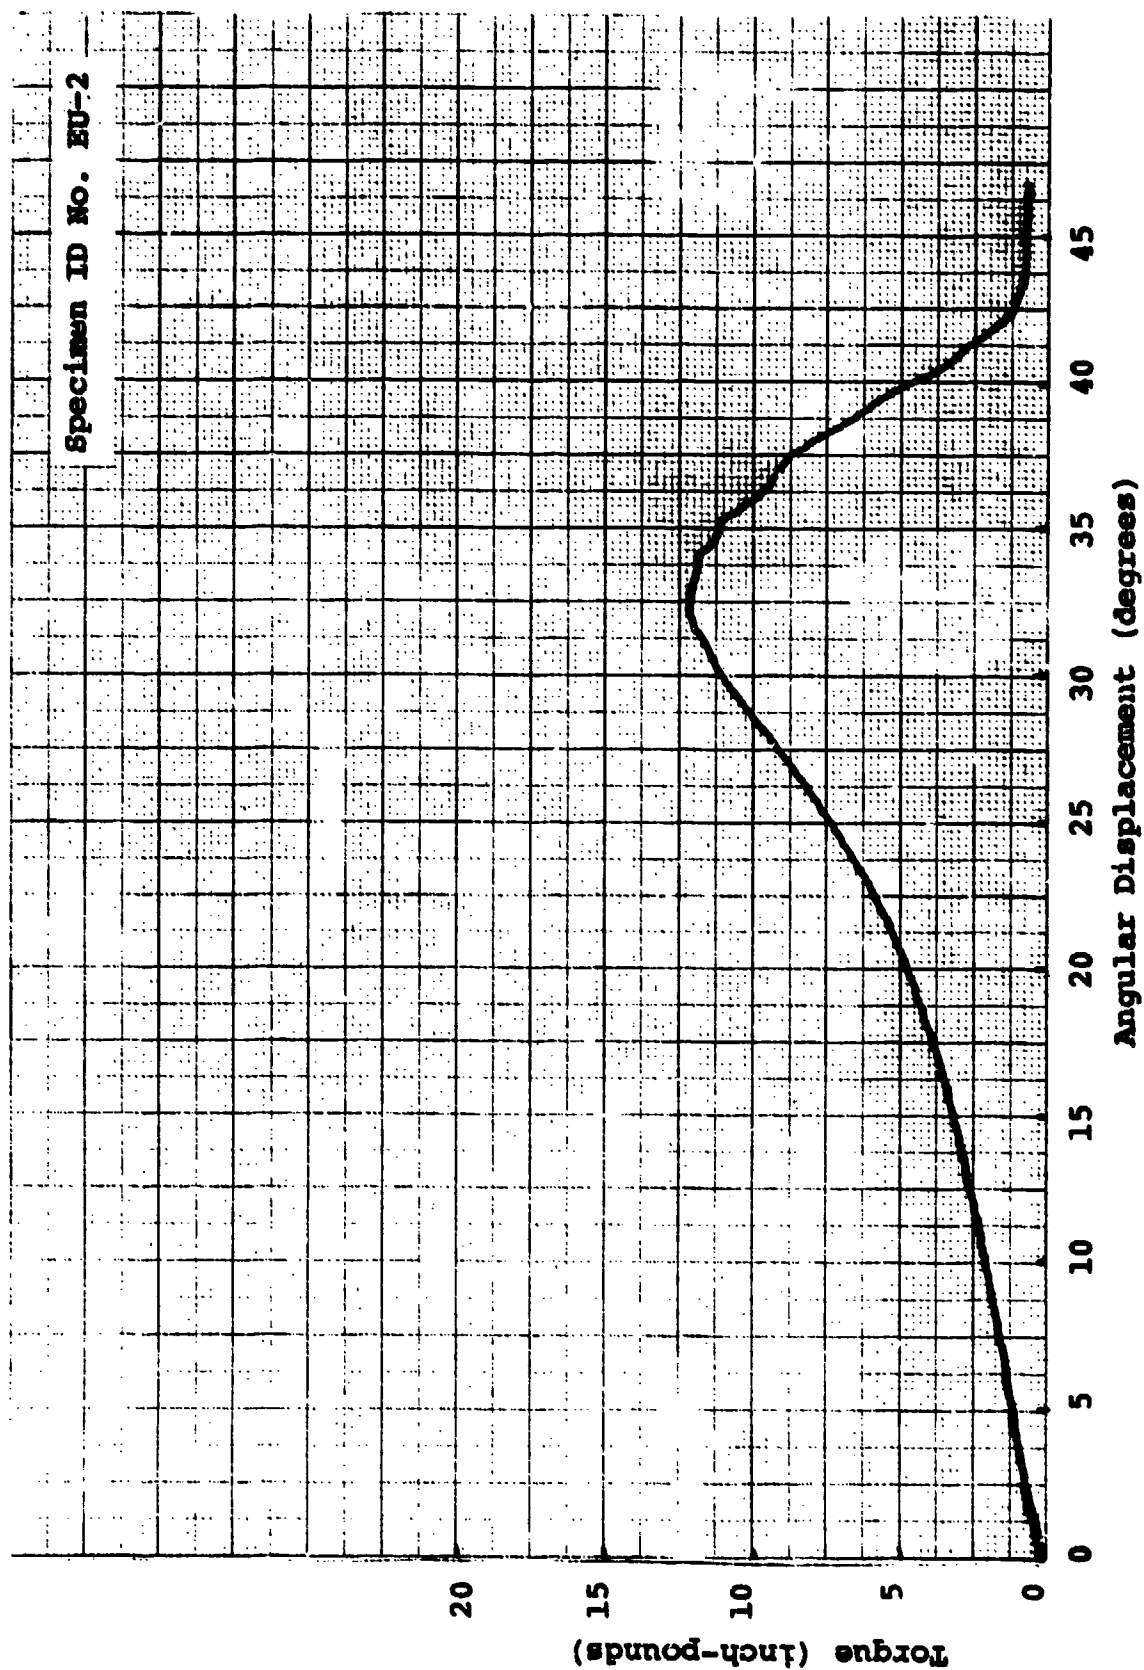
Figure 3.37. Typical Torque vs. Angular Displacement Plot, Torsional Shear, F-111 Laminated ADBIT Windshield.

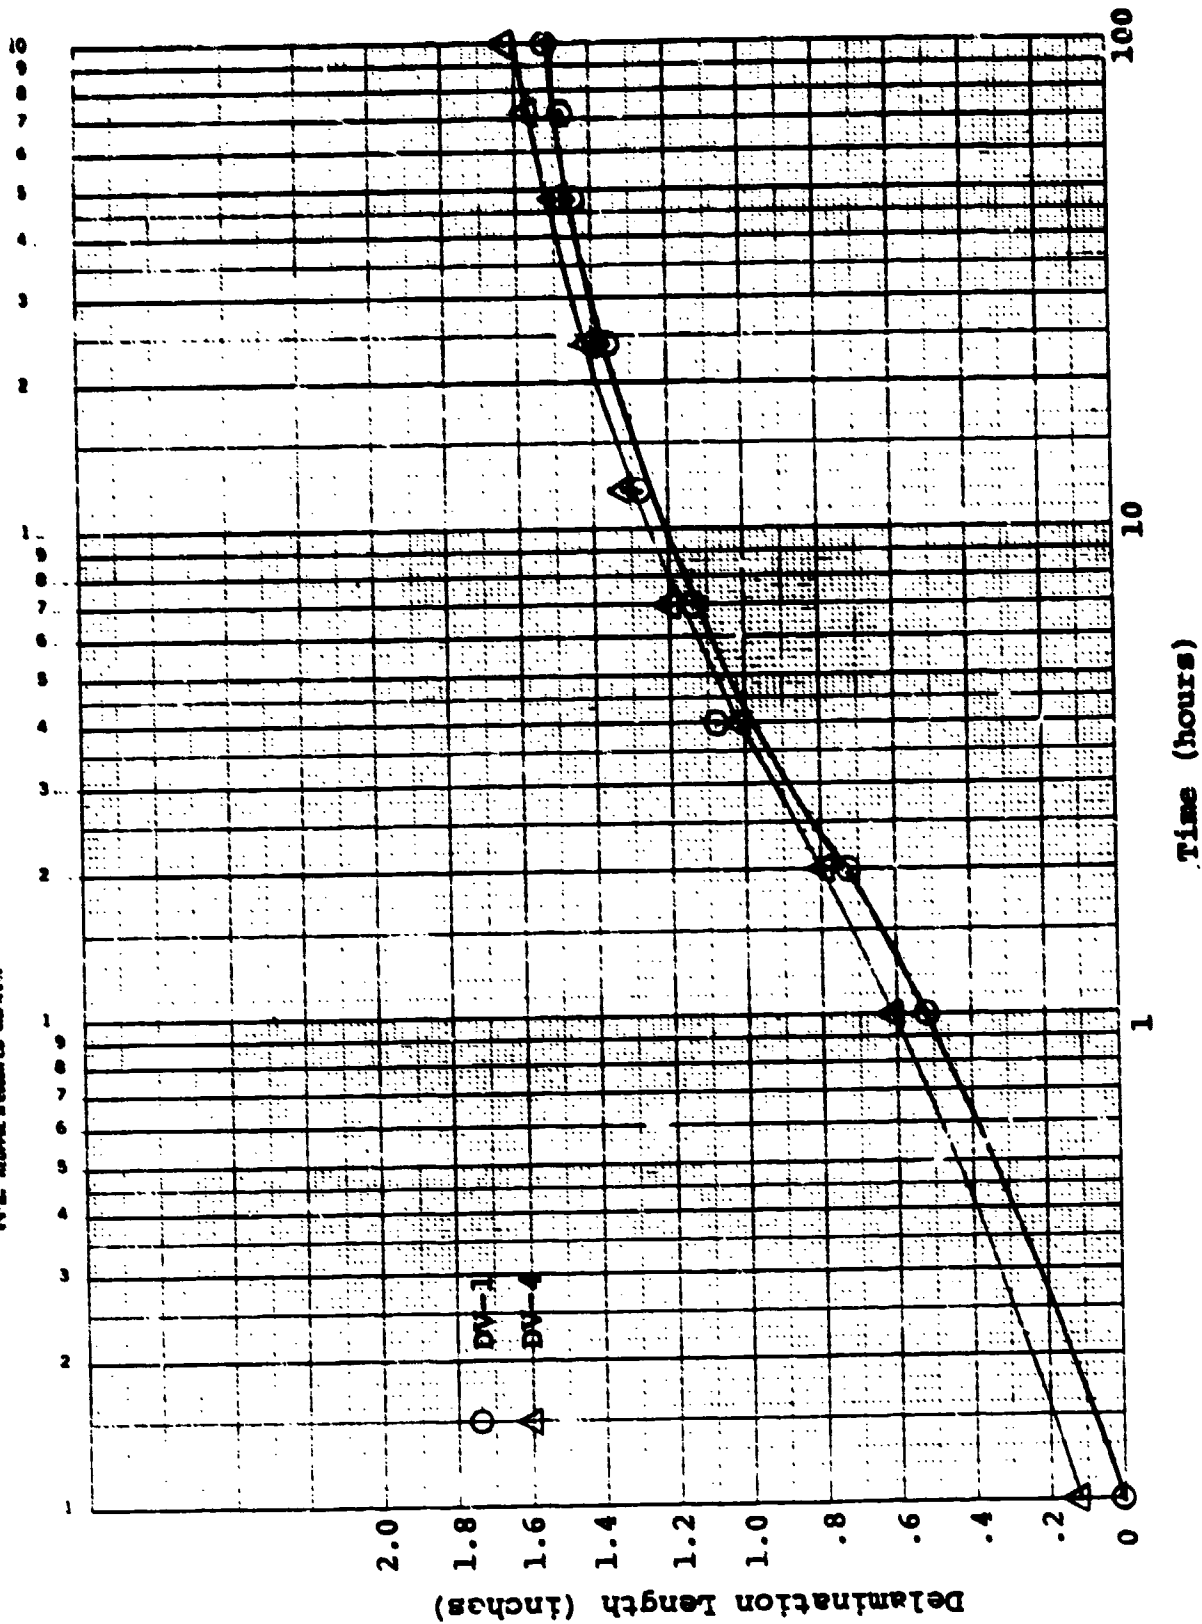
Figure 3.40. Summary of Wedge Peel Tests for F-16A Laminated Canopy

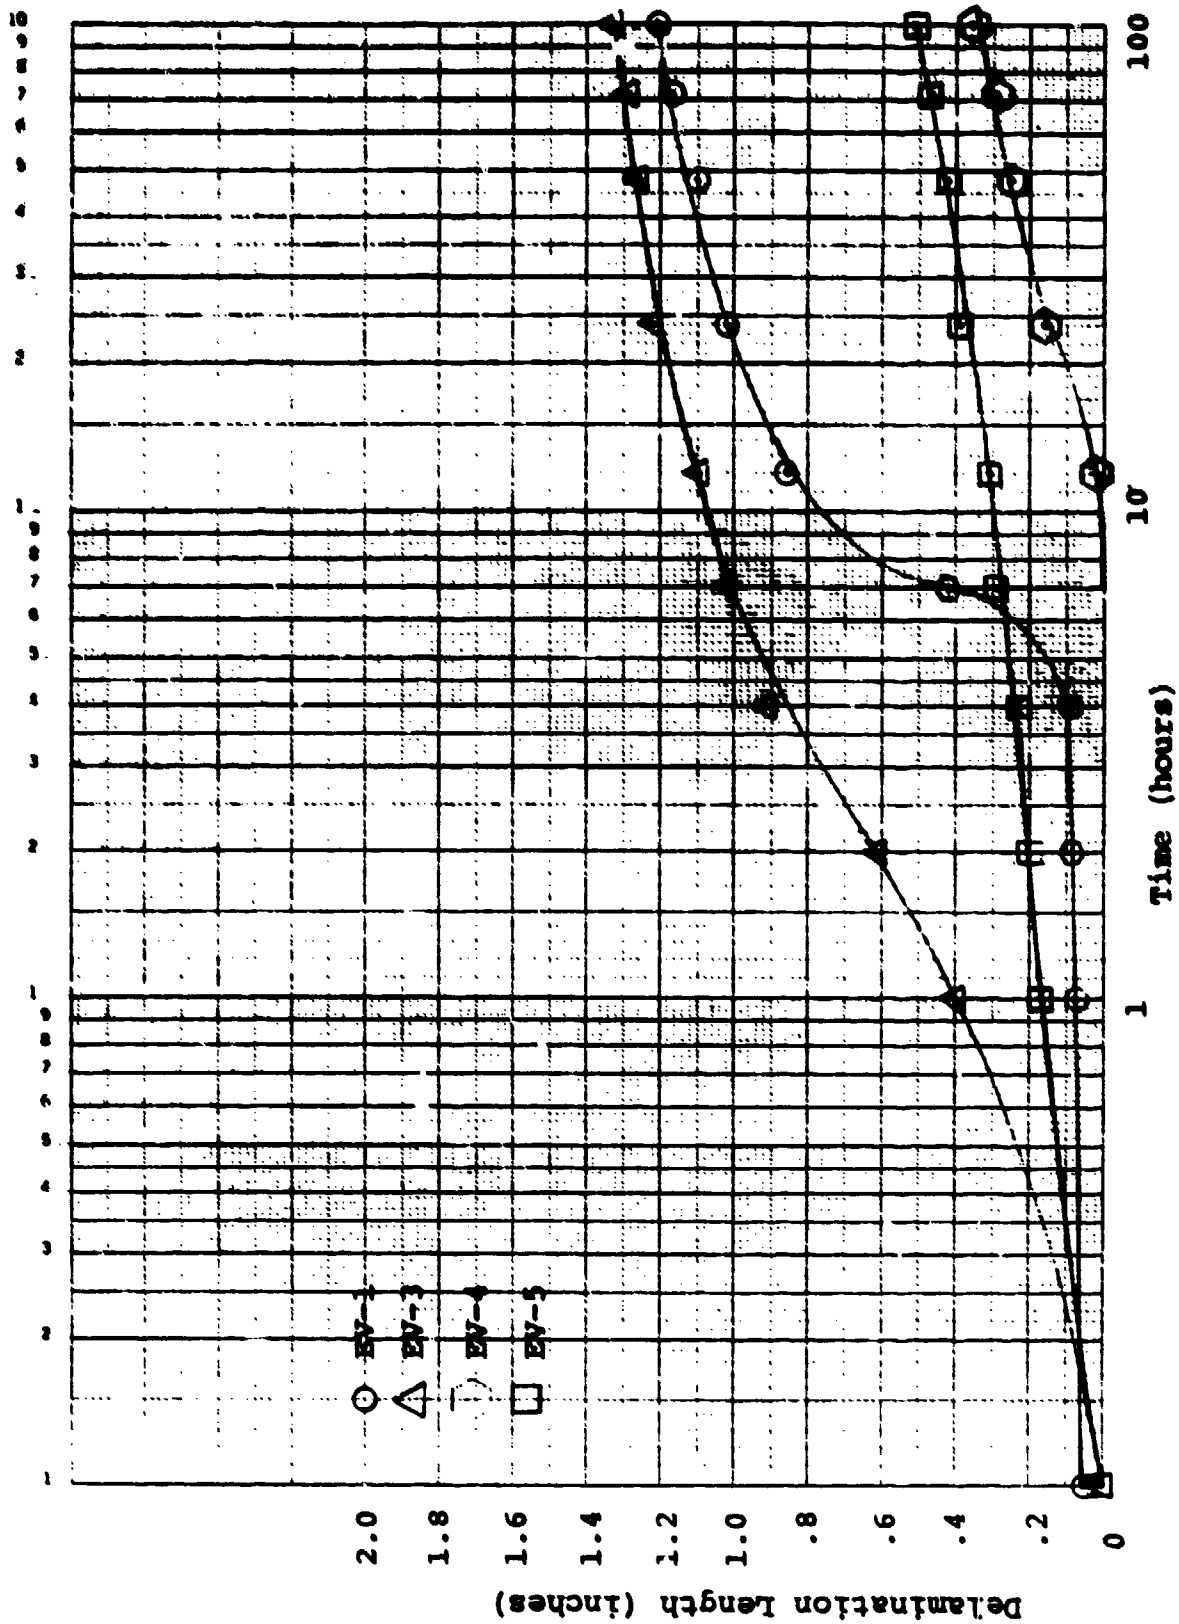
Figure 3.41. Summary of Wedge Peel Tests for P-111 ADBIRT Windshield.

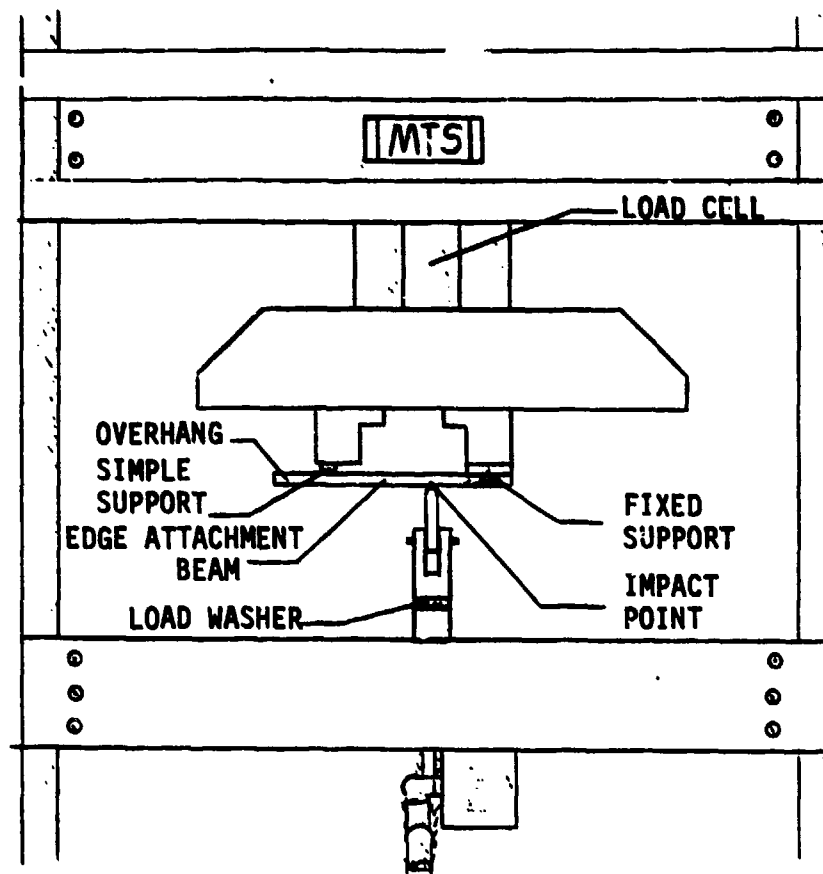
Figure 3.49. Edge Attachment Test Set-up.

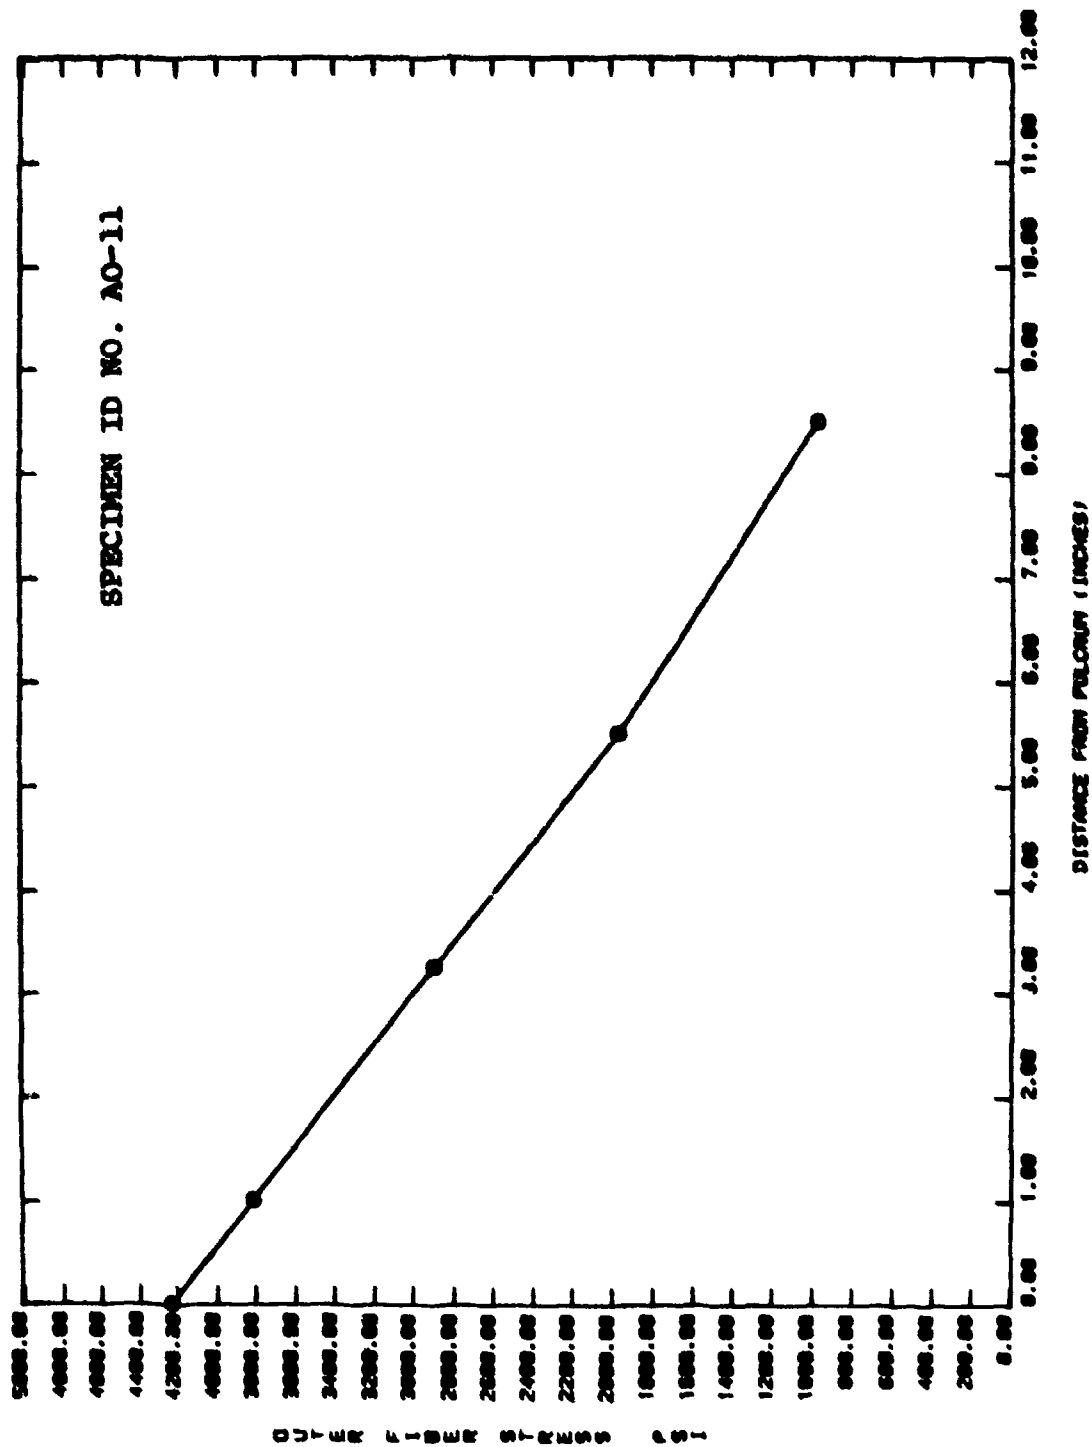
Figure A-6. Plot of Outer Fiber Stress versus Distance from the Fulcrum for the F-15 Monolithic Stretched Acrylic Windshield.

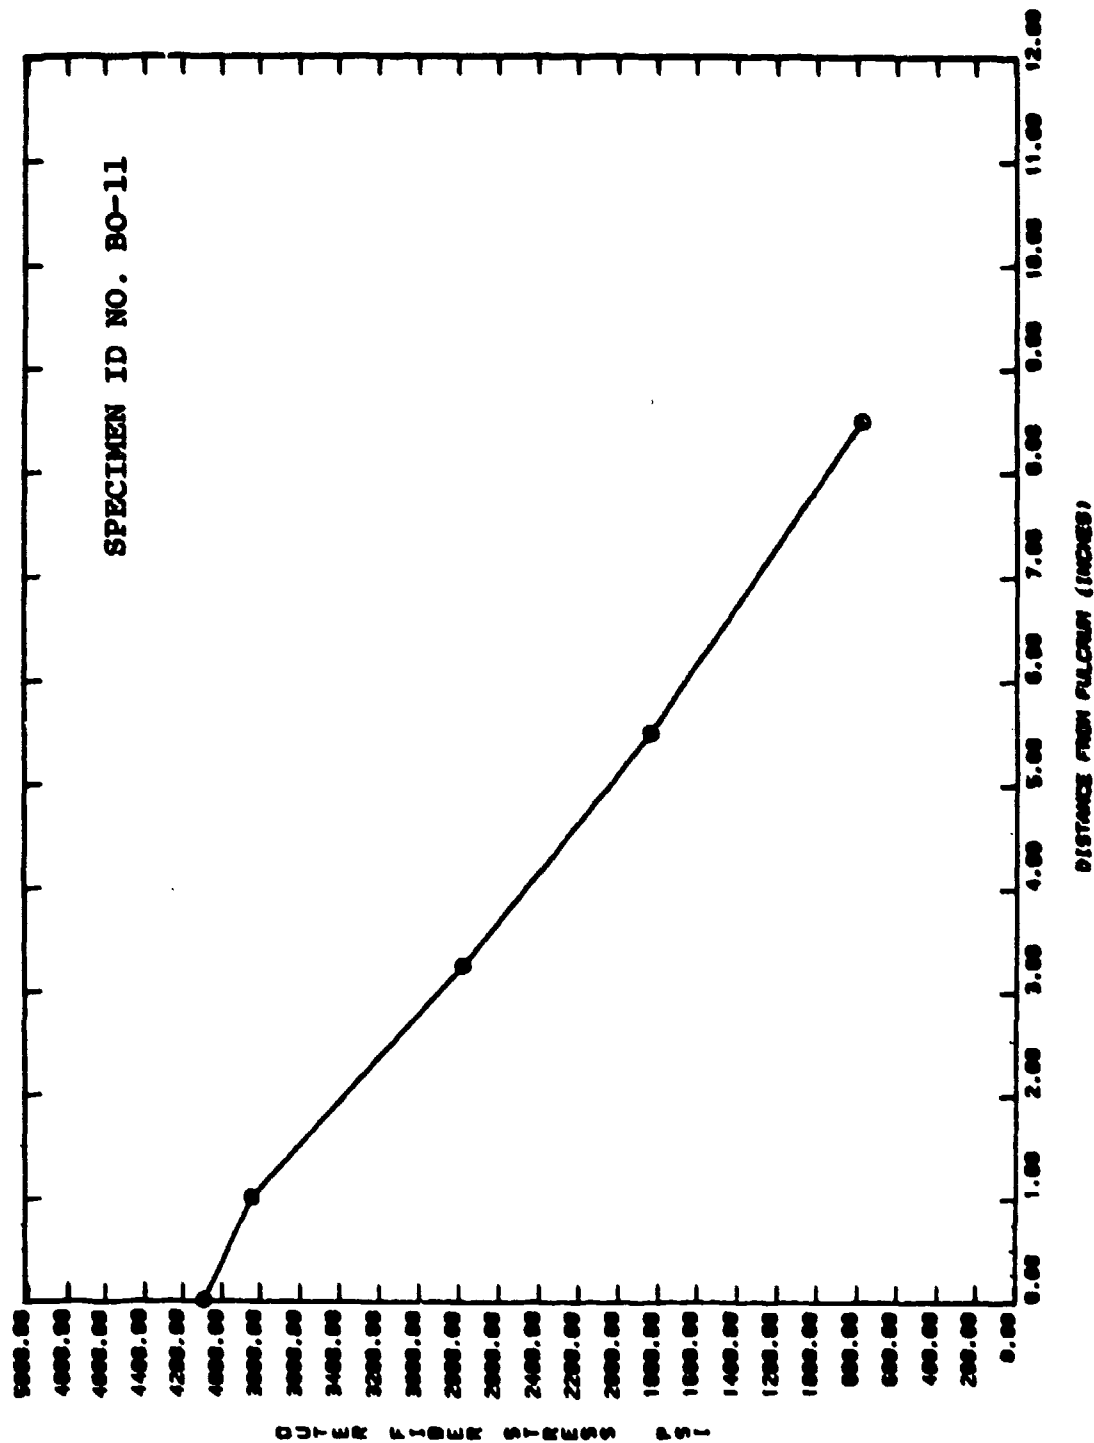
Figure A-7. Plot of Outer Fiber Stress versus Distance from the Fulcrum for the F-15 Monolithic Stretched Acrylic Canopy.

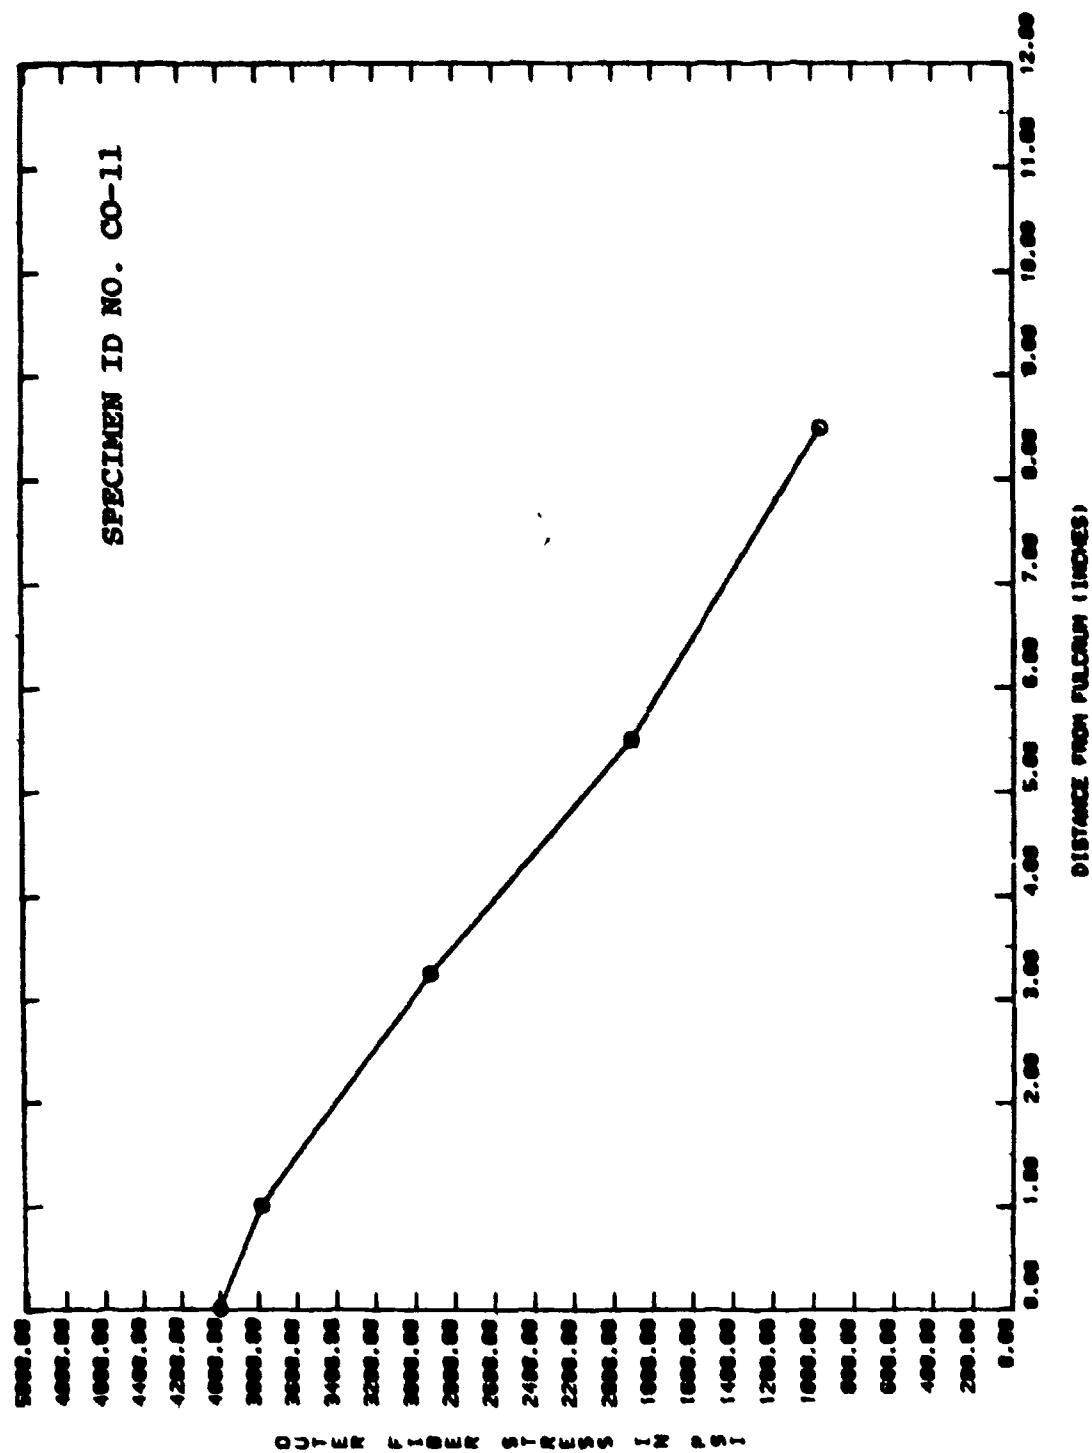
Figure A-8. Plot of Outer Fiber Stress versus Distance from the Fulcrum for the F-16A Coated Monolithic Polycarbonate Canopy.

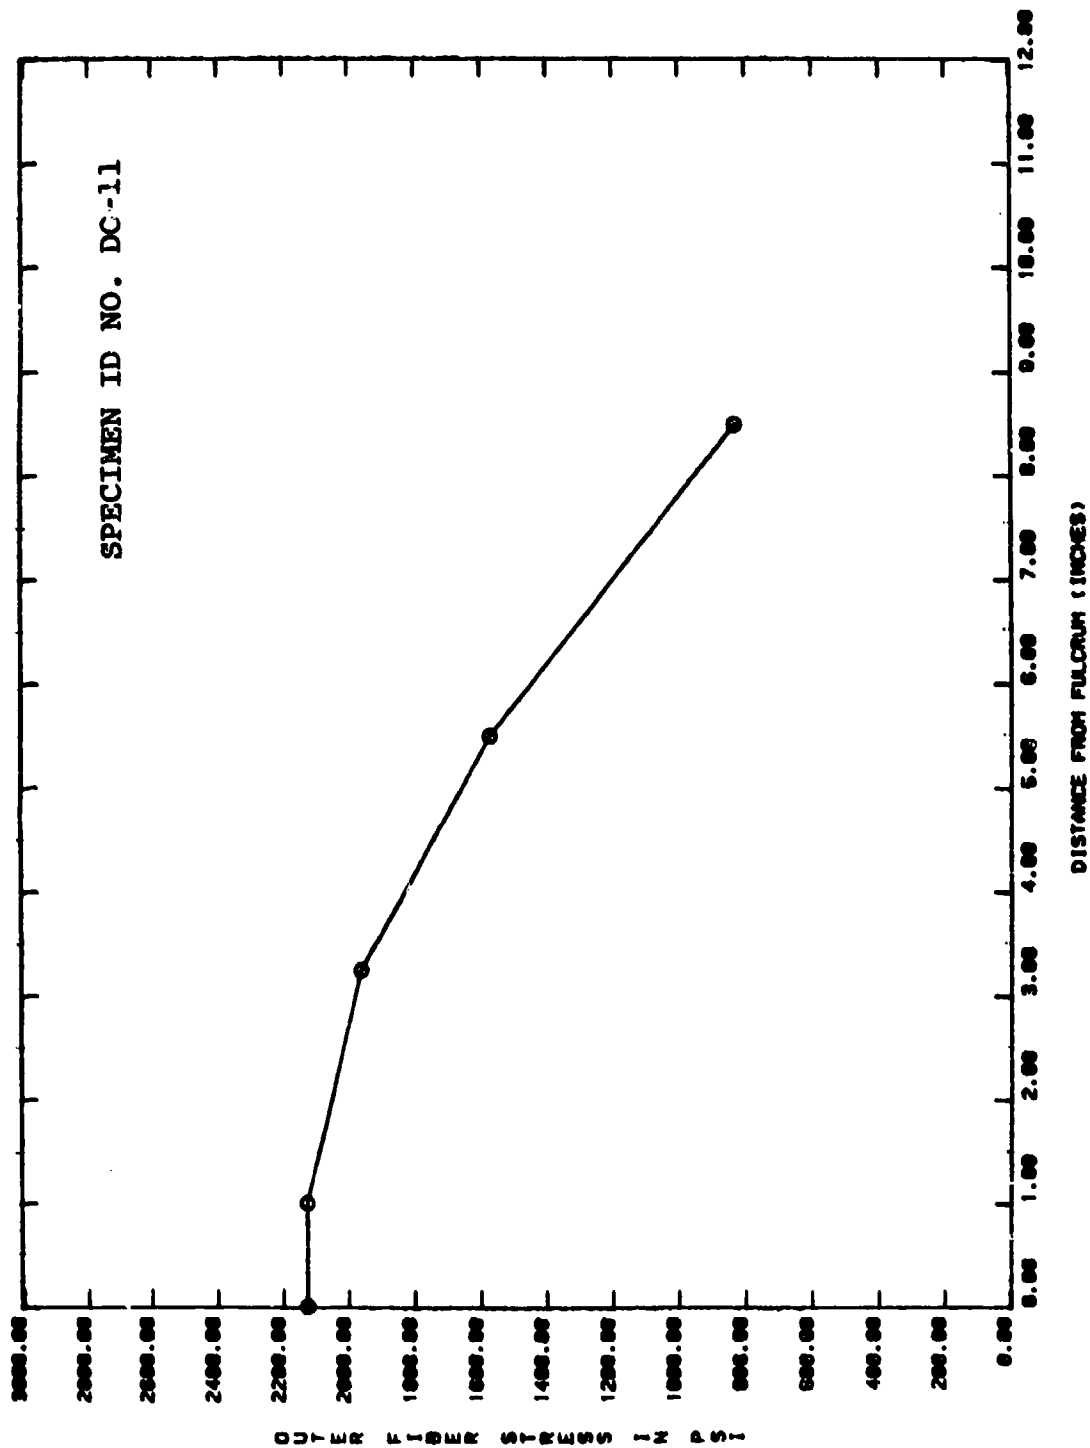
Figure A-9. Plot of Outer Fiber Stress versus Distance from the Fulcrum, for the F-16A Laminated Canopy.

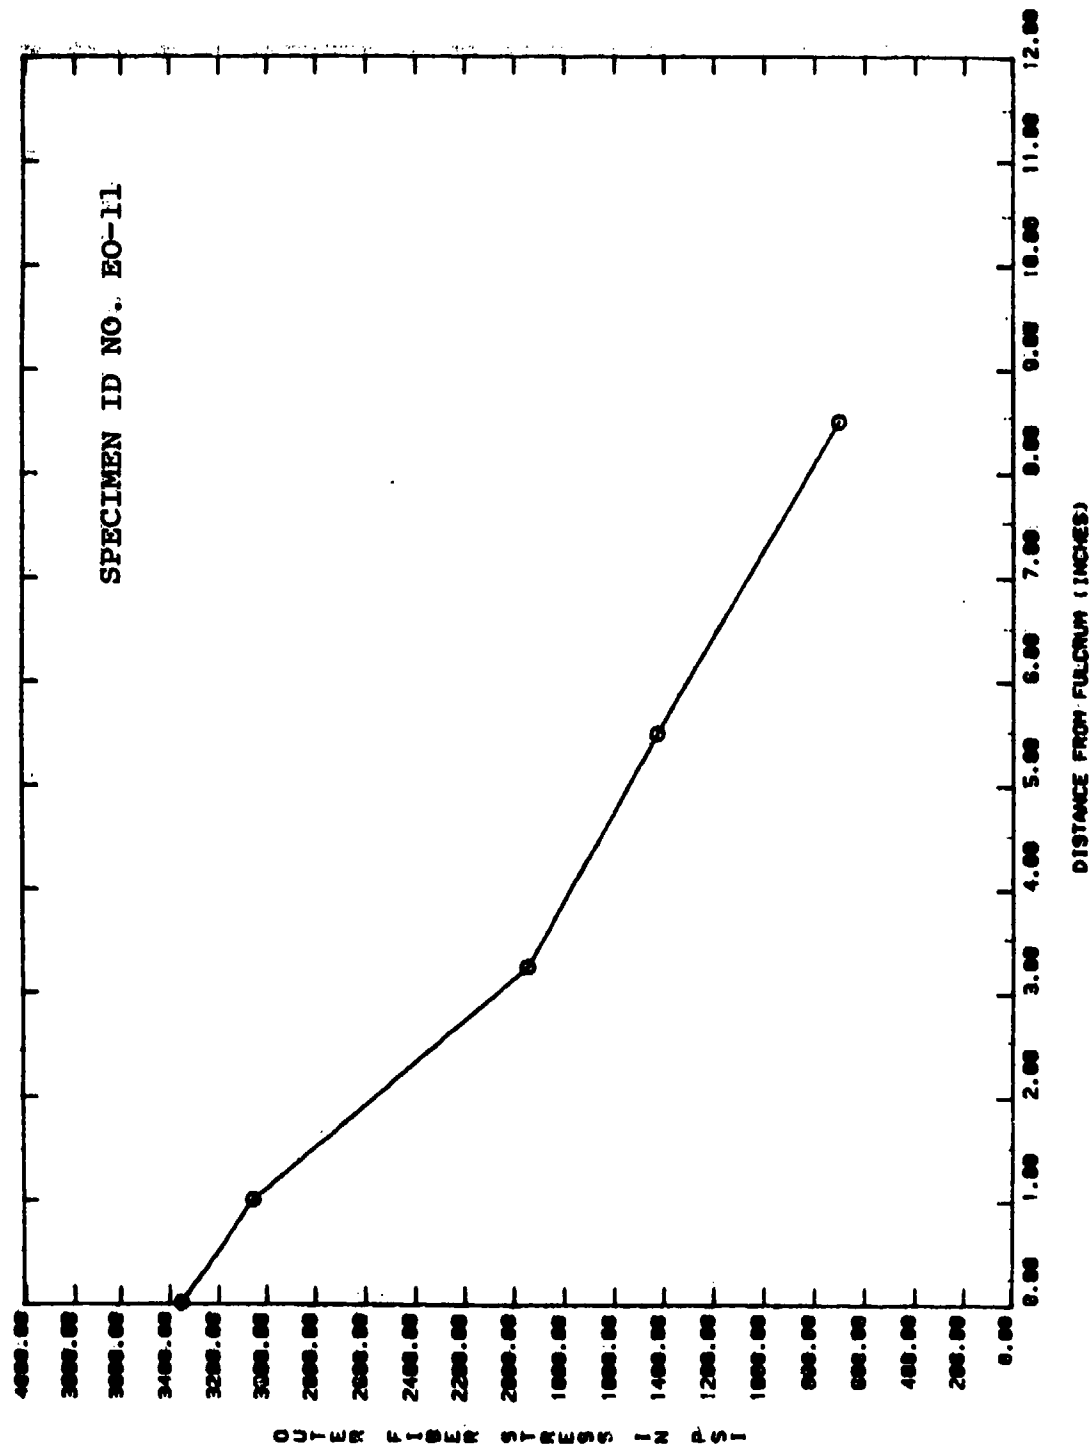
Figure A-10. Plot of Outer Fiber Stress versus Distance from the Fulcrum for the F-111 Laminated Windshield.
